Enclosure: (1) Coast Guard Proposed Findings of Fact, Conclusions & Recommendations;  
In the Matter of the M/V COSCO BUSAN allision with the San Francisco-  
Oakland Bay Bridge on November 7, 2007.

## **FINDINGS OF FACT:**

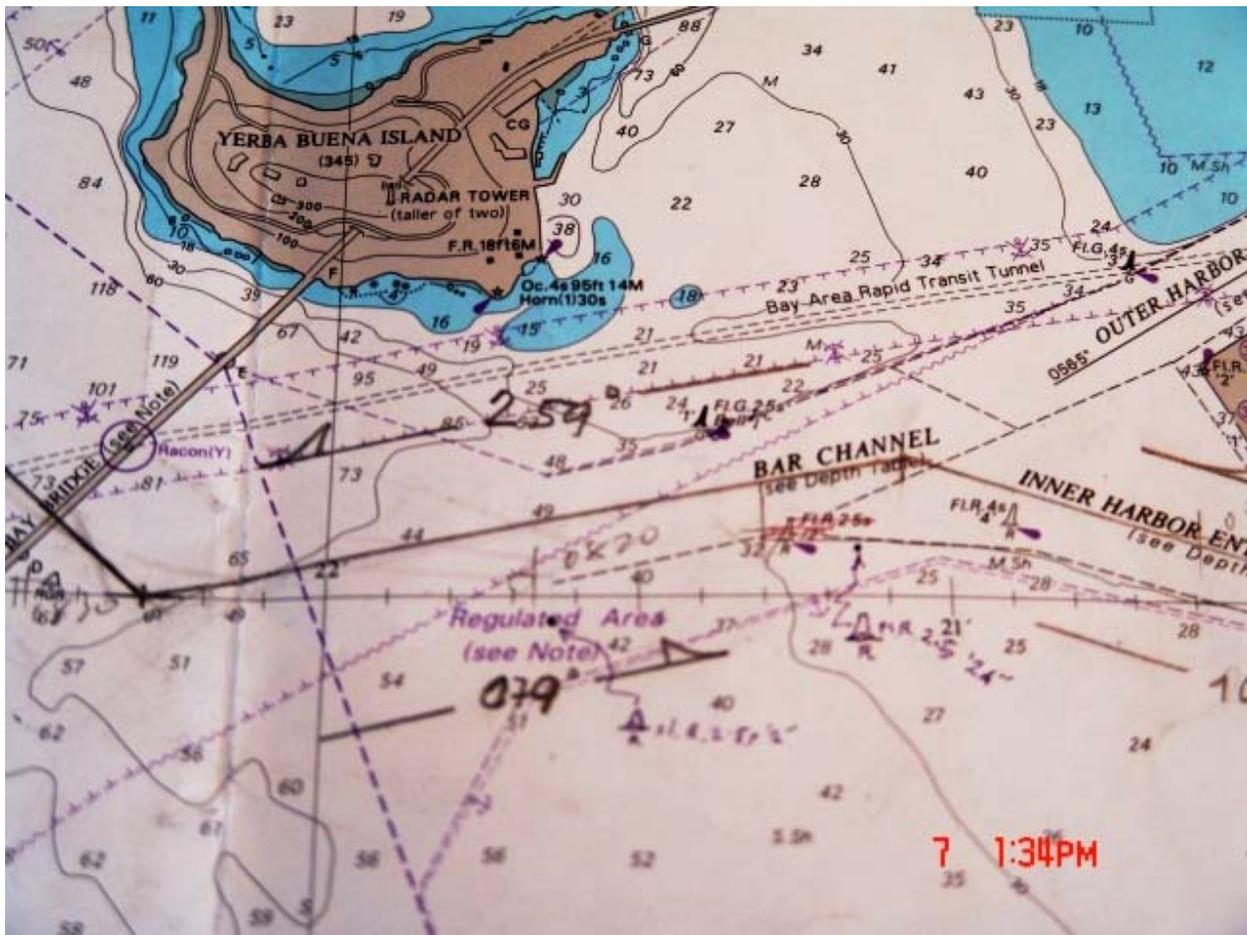
\*\* The charted course of 313 degrees True is just 0.05 NM (approximately 300 feet) northeast of the Delta Tower, extremely close for a prudent passage. While inbound, San Francisco Bar Pilot Einar Nyborg reviewed the vessel's chart and noted the planned outbound trackline was too close to the Delta Tower. He pointed this out to the crew, but the chart was not revised prior to departure as recommended by Nyborg.

Figure 1. Coast Guard photo of the navigation chart from the M/V COSCO BUSAN, with tracklines placed by the Second Officer prior to arrival. Note the “X” and “0820” (near the center of the photo) and “0830” notations, which are GIS positions plotted by the Third Officer while underway. This photo was taken before the Third Officer erased these positions after the casualty.

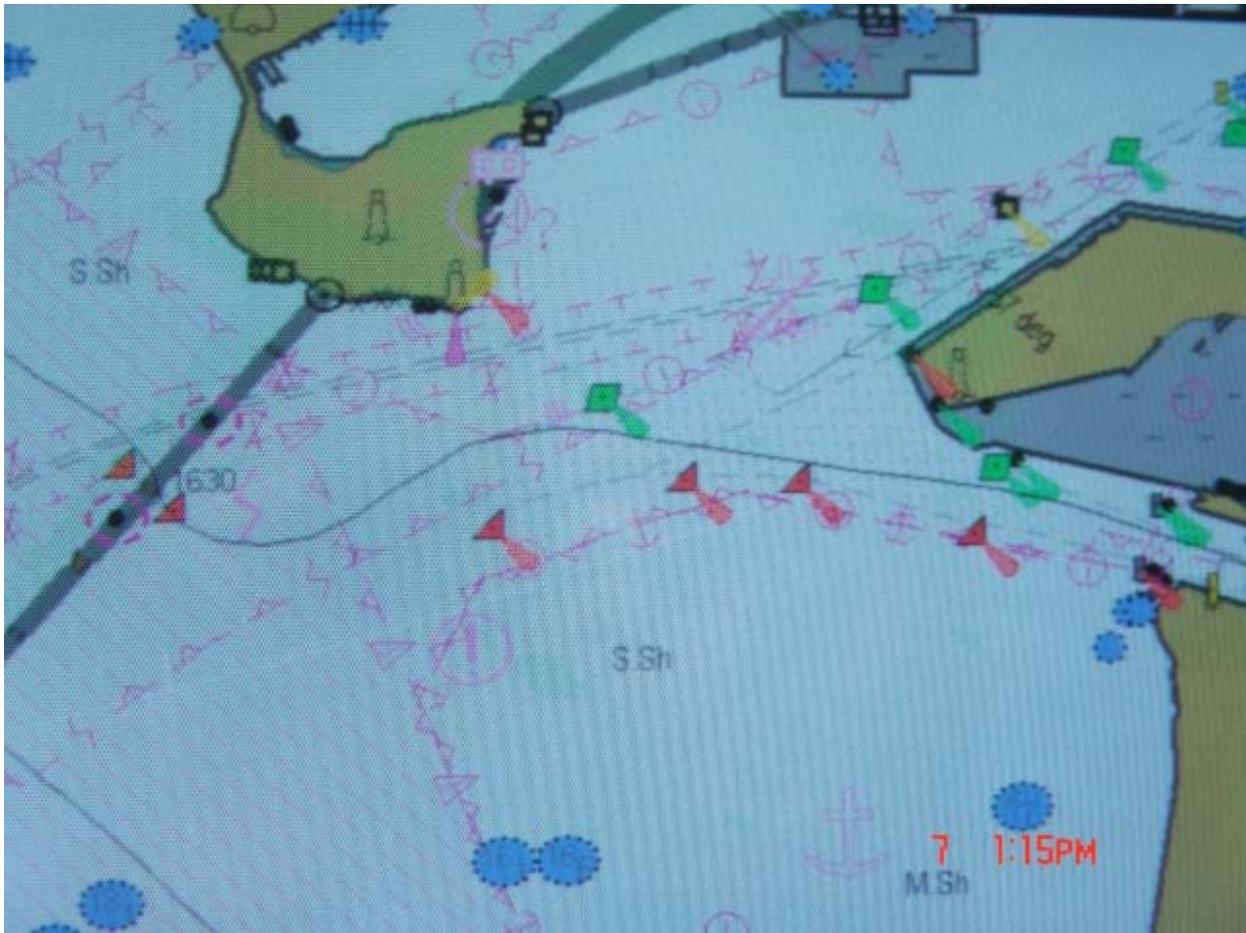
Figure 2. Coast Guard photo of the ECDIS display of the M/V COSCO BUSAN. Note the red triangle symbols with teardrops indicating lighted aids to navigation, and two red triangle symbols on either side of the Delta Tower Island, representing the buoys marking the Tower Island. The RACON symbols (dark circles with magenta broken halo) on the bridge are also clearly visible. The blue trackline is the vessel's AIS course.

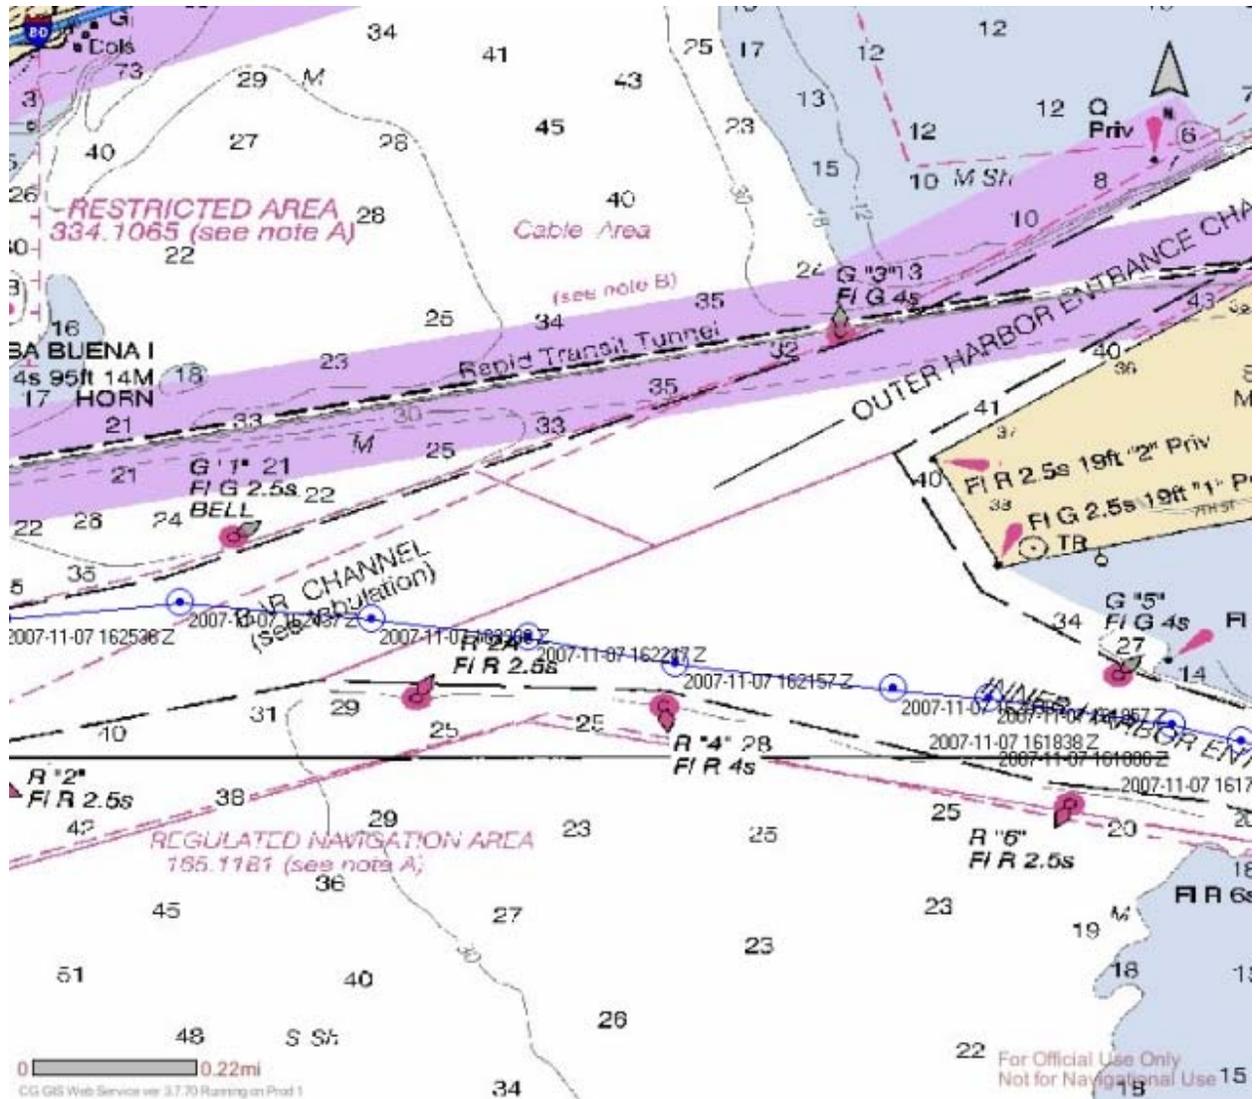
Figure 3. This image was prepared by the Coast Guard Office of Information Resources using AIS data at one minute intervals. Times shown are in Zulu (Greenwich Mean Time (GMT)), which can be converted to local time by deducting eight hours. This image shows the COSCO BUSAN's AIS trackline (indicated in blue) from Lighted Buoys "5" and "6" to Lighted Buoy "1."

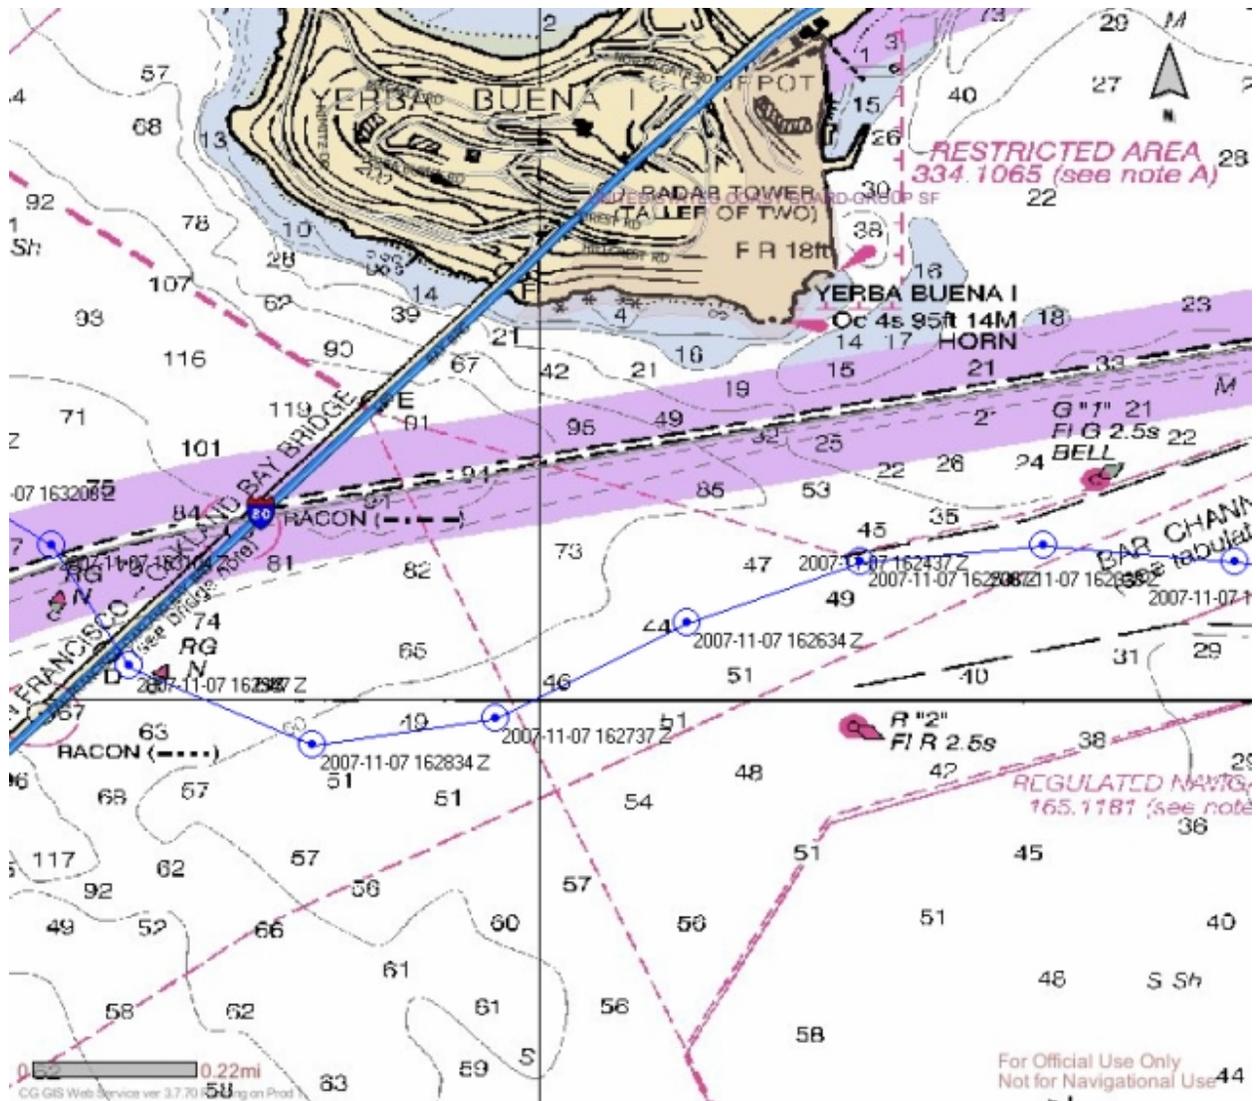
Figure 4. This image was prepared by the Coast Guard Office of Information Resources using AIS data at one minute intervals. Times shown are in Zulu (Greenwich Mean Time (GMT)), which can be converted to local time by deducting eight hours. This image shows the COSCO BUSAN's AIS trackline from Lighted Buoy "1" to a point northwest of the Delta Tower of the Bay Bridge, after the allision.

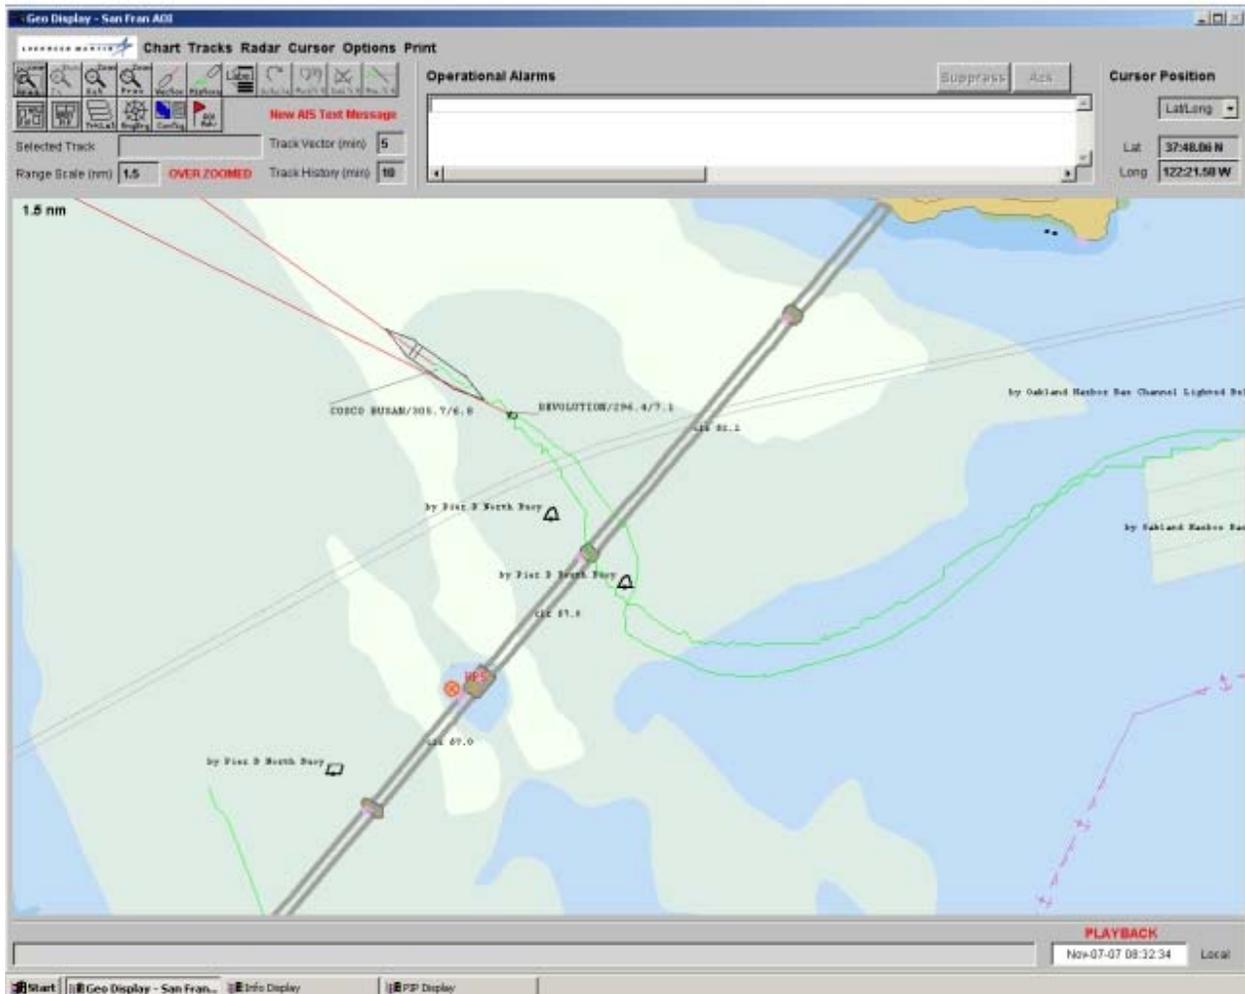
Figure 5. This image was recovered from the Coast Guard Vessel Traffic System (VTS) after the casualty. The green lines are the tracklines of the M/V COSCO BUSAN and the Tug REVOLUTION respectively. Note how the tug crossed the wake of the COSCO BUSAN as the ship maneuvered.

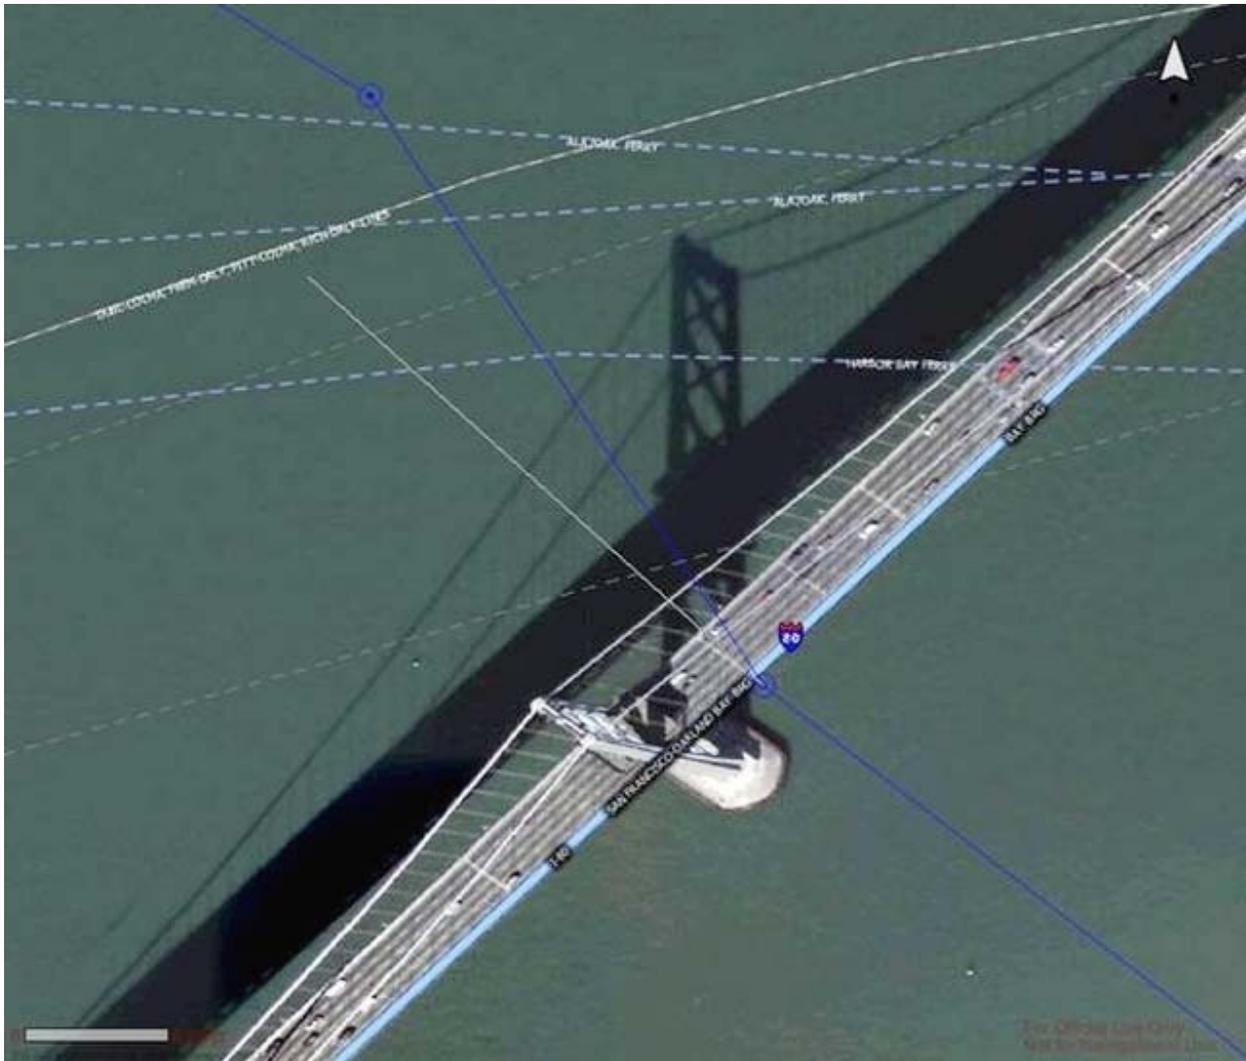
Figure 6. Aerial view of the Bay Bridge (Delta Tower) with the AIS trackline of the M/V COSCO BUSAN in blue.

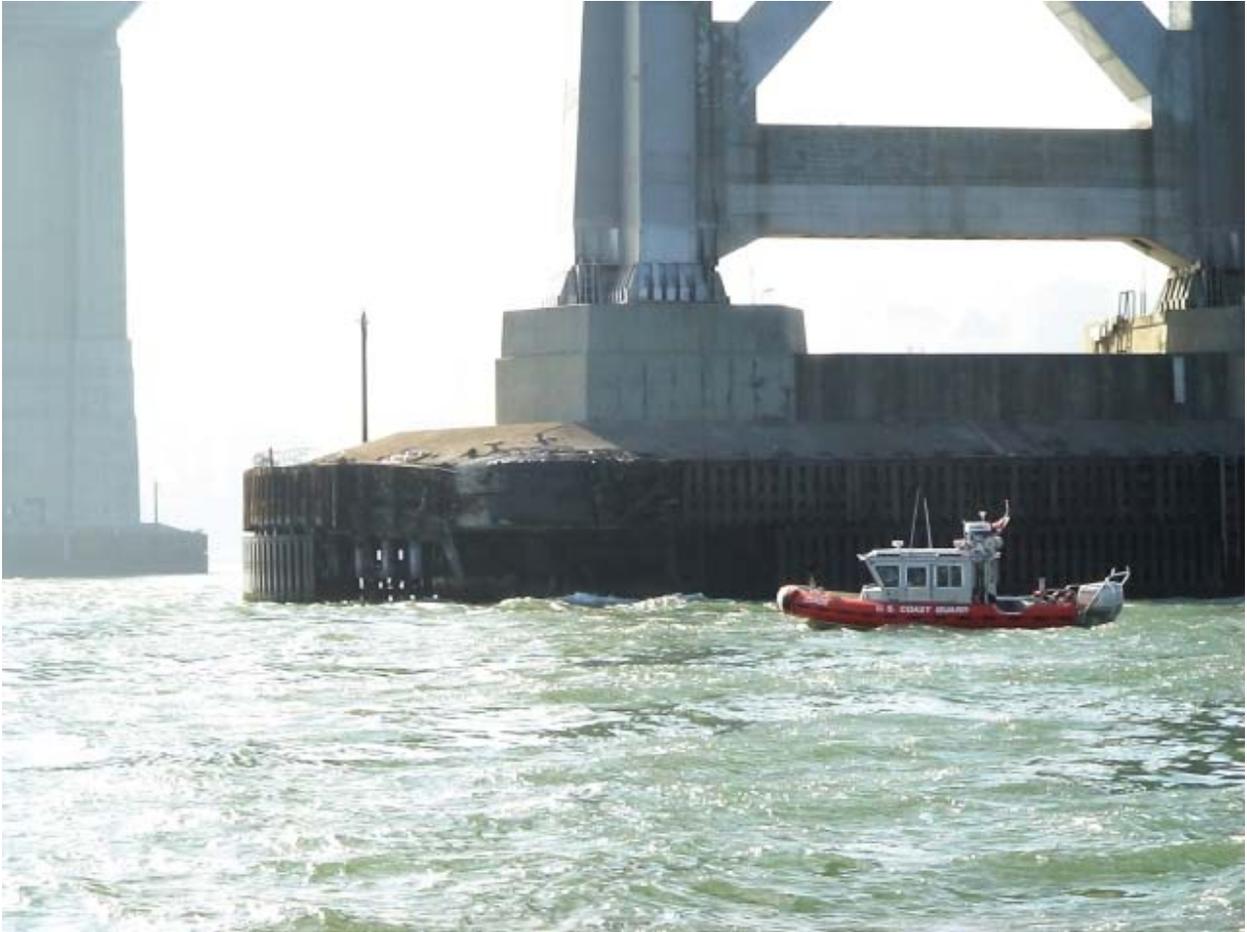
\*\* As a result of the allision, the Bay Bridge sustained damage to the wood and plastic fender system and concrete tower support. Some fender material that fell into the water was recovered by the Army Corps of Engineers (ACOE), and some washed up on beaches in the days following the casualty.

\*\* The Bridge was inspected by the California Department of Transportation (CALTRANS) and found structurally sound. The estimate for repairs to the fender system was between \$1.5 to \$2 million.

Figure 7. Coast Guard photo of fender system damage to the Bay Bridge

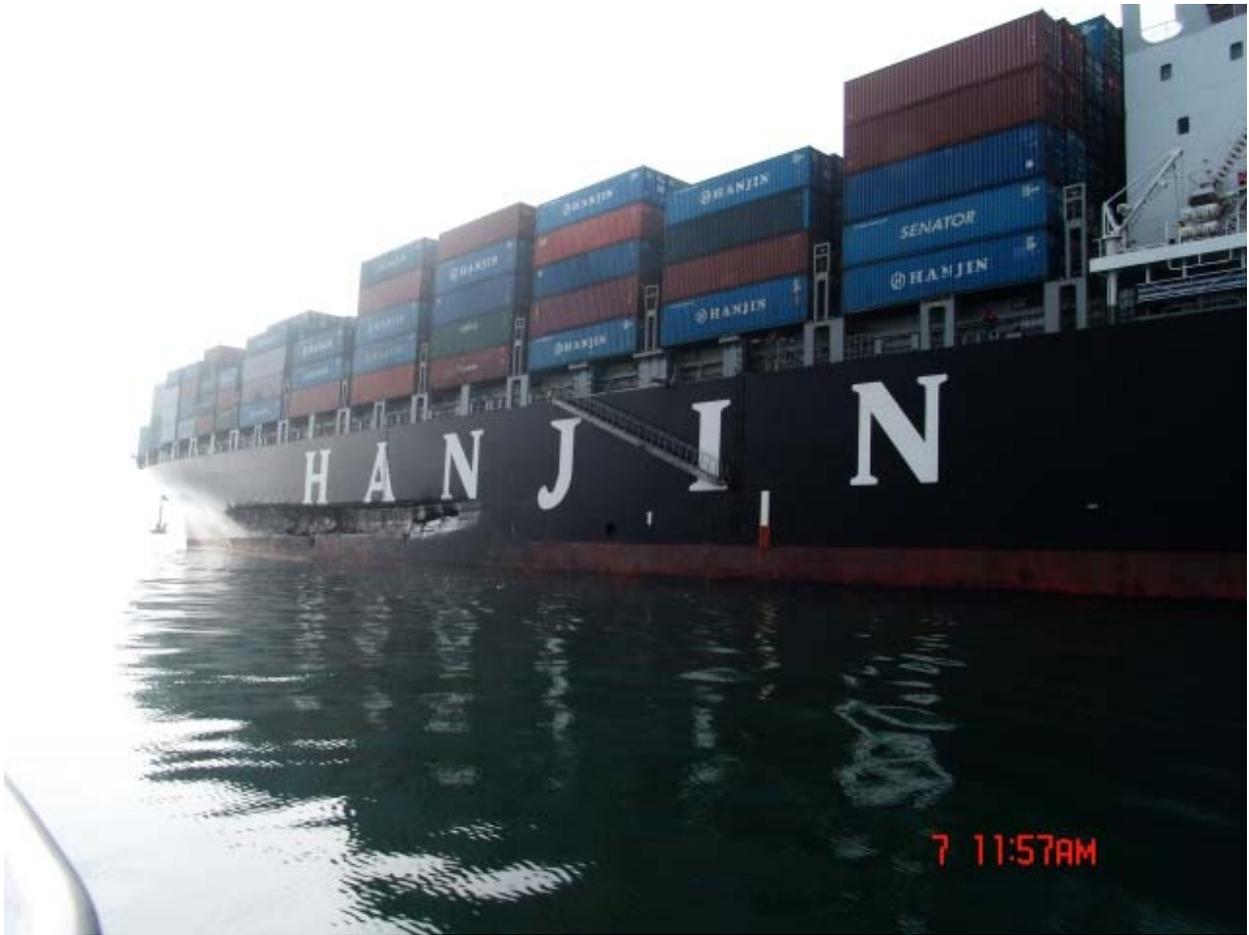
\*\* As a result of the allision, the COSCO BUSAN sustained significant structural damage to the port side shell above the waterline between frames 128 and 150. The hull was breached to a height of three meters, and inboard to the longitudinal bulkhead, which was buckled and punctured in way of cargo hold #2. All associated internals were completely destroyed.

\*\* The side shell of the COSCO BUSAN was damaged in way of the #2 water ballast tank, #3 wing fuel oil tank and #4 wing fuel oil tank. The fuel oil level in the #3 tank was below the lower edge of the damage, and thus it is unlikely that there was a substantial flow of oil, if any, from the #3 fuel oil tank. The #4 fuel oil tank discharged an estimated 53,653 gallons of Intermediate Fuel Oil (IFO 380).

Figure 8. Coast Guard photo of damage to the M/V COSCO BUSAN

\*\* Temporary repairs to the COSCO BUSAN were completed in San Francisco at an estimated cost of \$1 million. Permanent repairs were completed outside the U.S., at an estimated cost of \$1.5 million.
